# Microplastics in groundwater

Aiga Mackevica & Nanna B. Hartmann

# Part 2: Measurements of MPs in Danish groundwater

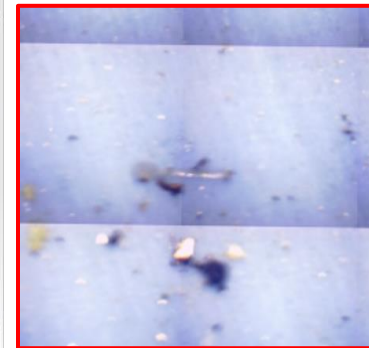
- Mortenstrup (Hørsholm), 50L - replicate nr.3.
  - Results: PET particle (rod-shaped, ca. 250μm x 50μm)
